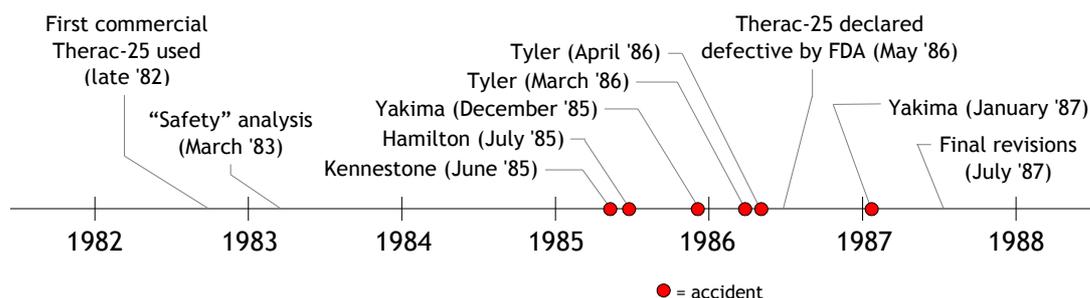
Figure 2. Therac-25 Timeline

The first accident (see Figure 2 for a timeline of all accidents) occurred at the Kennestone Regional Oncology Center in Marietta, Georgia on June 3, 1985. Many of the details of this incident were unclear since it was never reported or investigated, but the patient was a 61-year-old woman who was undergoing radiation treatment for a malignant tumor in lymph nodes near her left breast. A
